CRS Site Group Response to USEPA August 18 Comments re  
seeps

**Chemical Recovery Systems, Inc. (CRS) Site Group  
Response to E-mailed Comments  
from Gwen Massenburg, RPM, U.S. EPA Region 5  
(Received 18 August 2004)**

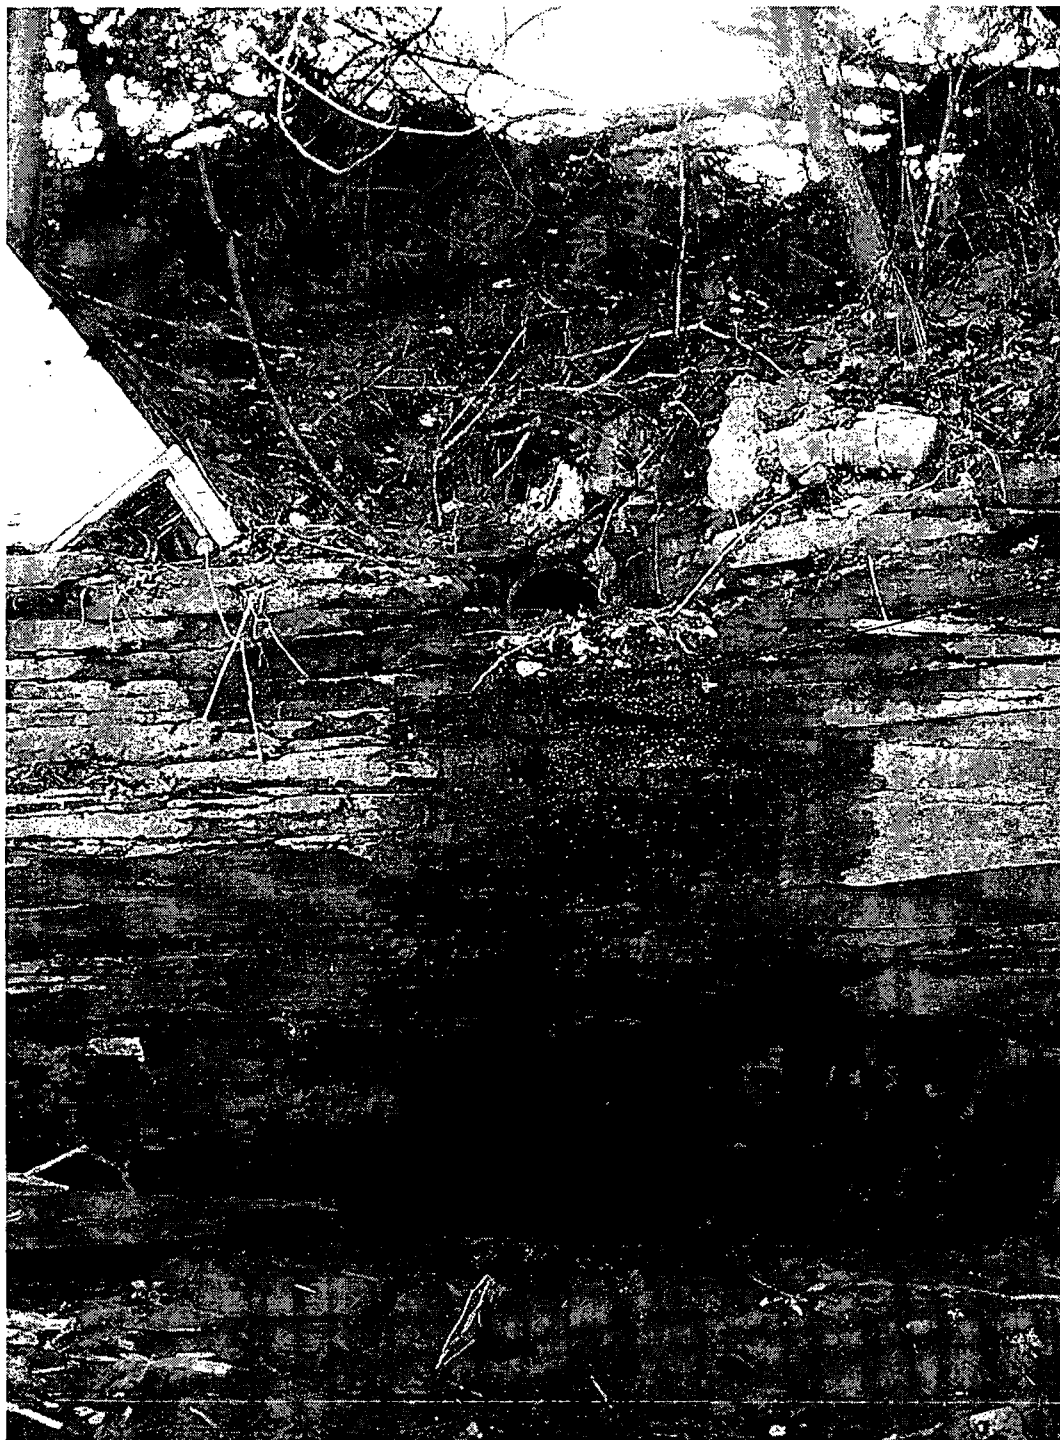
A site visit was conducted on 23 August 2004 by the Parsons Project Manager and Senior Hydrogeologist and a review of the River bank indicated that there was no free-flowing water emanating from the bedrock and/or slope, other than what can be attributed to the limited flow from or around the circumference of the 12-inch pipe. Water was not observed emanating from beneath the debris associated with "location one." The majority of limited water observed in "location two" can be attributed to the 12-inch pipe (see attached picture). The 12-inch pipe is not the city storm sewer. Moisture was observed in a few bedrock bedding planes, however, there was no free-flowing water and there is not a sufficient quantity of water for sample collection.

Limited water flow  
from 12-inch pipe

Water sweating  
from bedding planes

The risk assessment will be amended to indicate there is a possibility that there may be a minor unquantifiable volume of water emanating from bedrock and/or slope at the above locations. As the volume of water is unquantifiable, potential exposure to the water will be qualitatively evaluated in the risk assessment. Piping protrusions along the River, with the exception of the city storm sewer, will be addressed in the remedial design and pulled and/or plugged as warranted.
